GROUND

Subject: Initial Geologic Hazard Evaluation,
Minturn Segment, **Eagle Valley Trail**, Eagle
County, Colorado

Job No. 15-6013

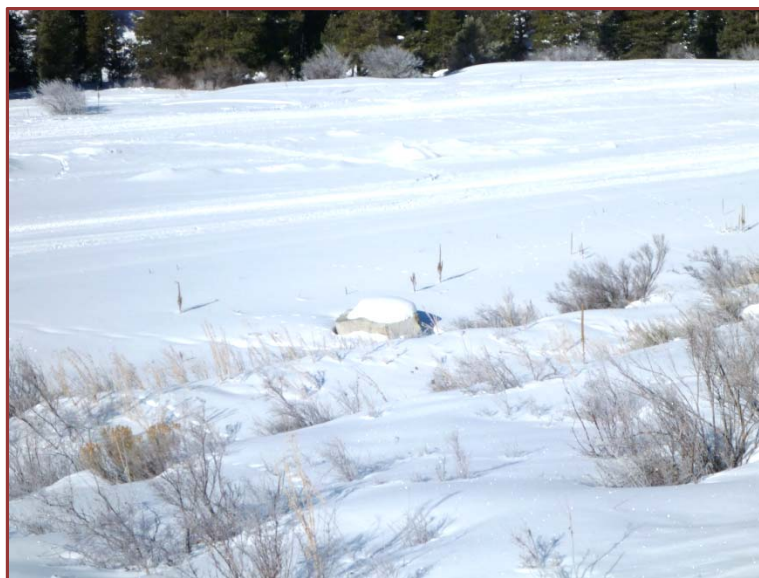
The steep slopes flattened downward to form an irregular valley floor sloping gently to moderately southwestward toward the river. Along a trend about 200 to 400 feet east of the river, an abrupt slope descended for 10 to 20 feet onto the nearly flat-lying terrace that lay just above the active river channel. The terrace below the abrupt slope is shown in the photograph at right. (The slope descending to the river terrace was less abrupt near the northern and southern ends of the trail segment.)

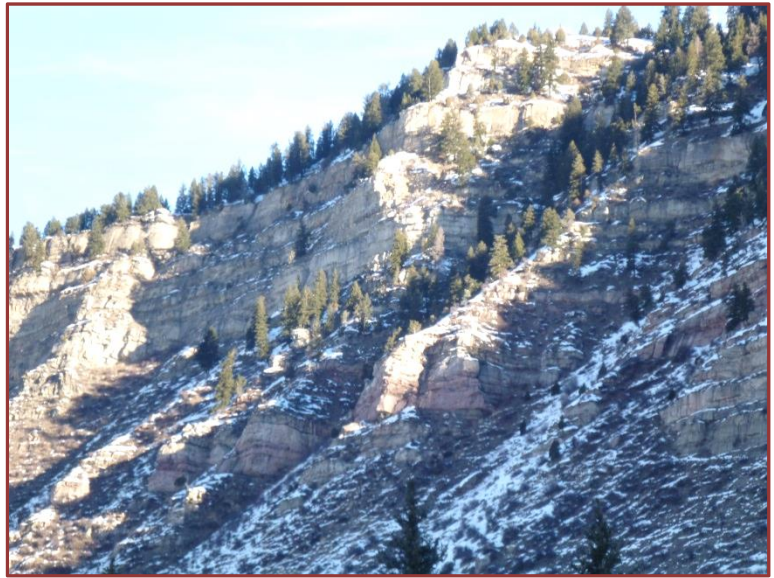
with thin beds of limestone. The Minturn Formation consists of gray to locally red sandstones, conglomerates and shales, with beds of limestone and dolomite within the other deposits. Exposures of the Minturn Formation above the subject trail segment are shown in the photograph at right. The beds of the Minturn Formation dip (are tilted) to the northeast at 10 to 15 degrees below the horizontal. The alluvial deposits consist of boulders, cobbles, gravel and sand.

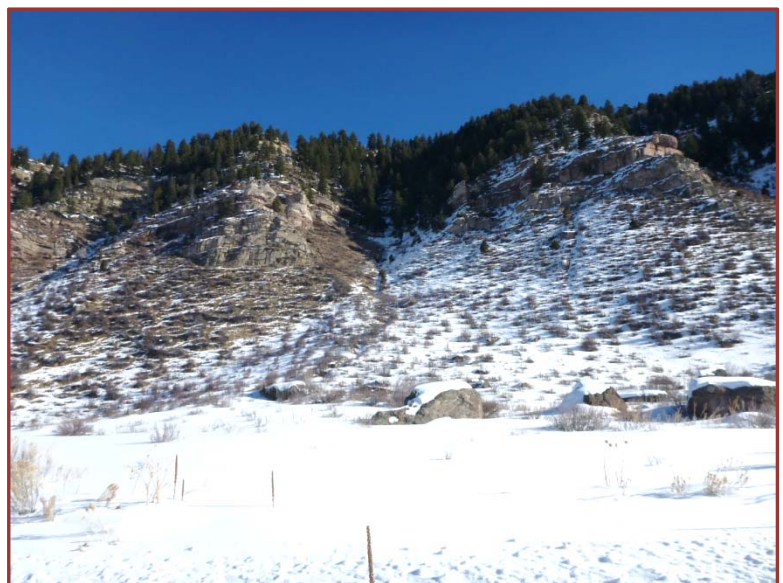
Debris Flows A series of debris flow fans occupied the area between the steep slopes and the stream terrace on which the rail line and the preferred trail alignment lay. Minturn Road and the alternative trail alignment traversed the lower, distal portions of these fans. The snow-covered surface of a debris flow fan is shown in the foreground of the photograph at right, composed of material derived from the gullies in the overlying slopes.

The debris flow fan deposits were formed by accumulation of material from episodic debris flows bringing sand, gravel, cobbles and boulders off the heights to the northeast. The 'toes' of the debris fans were truncated by erosion on the southwest forming the 'abrupt slope' descending to the river terrace. This suggests that the fans are relatively inactive and that the risk of debris flows affecting either trail alignment is relatively low, although we consider some risk of debris flows to remain. The debris flow risk to the lower, preferred alignment appears significantly lower than the alternative alignment.

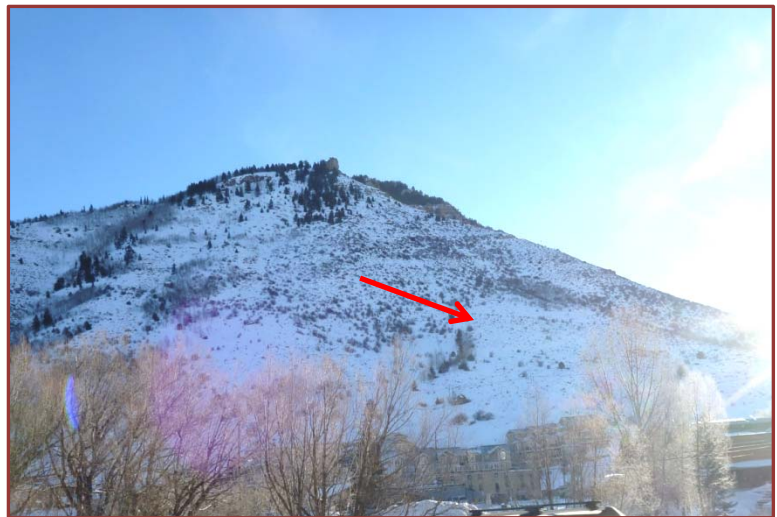
Slope Stability A quantitative analysis of the stability of the slopes overlooking the subject trail segment was beyond the scope of this initial evaluation. However, the dip of the bedrock to the northeast, i.e., back into the slope, tends to enhance gross stability of those slopes, however. Observation of the slopes suggested only one area near the southern end of the alignment that may be a feature resulting from past, relatively large

scale slope failure. This area is indicated by the arrow the photograph above. The feature is relatively subdued suggesting that if it is the result of a past slope failure, that event likely happened centuries ago. The risk of large scale landsliding affecting the Minturn Segment of the trail is considered low. Mitigating such risk, in any case, likely is beyond the scope of trail construction. Construction of either alignment of the trail does not appear to result in a significant decrease in large scale slope stability. Locally, of course, grading for the trail may result in local slopes that will require stability analysis. Retaining walls along either alignment may require evaluation for global stability.

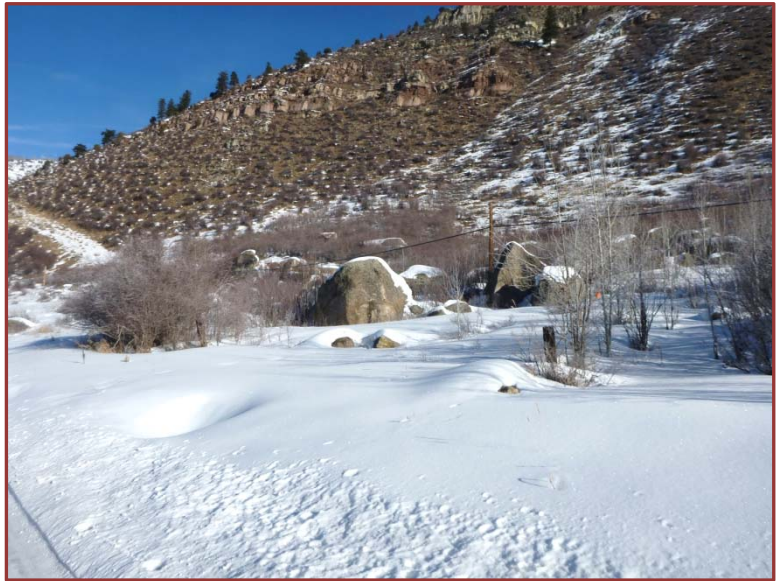
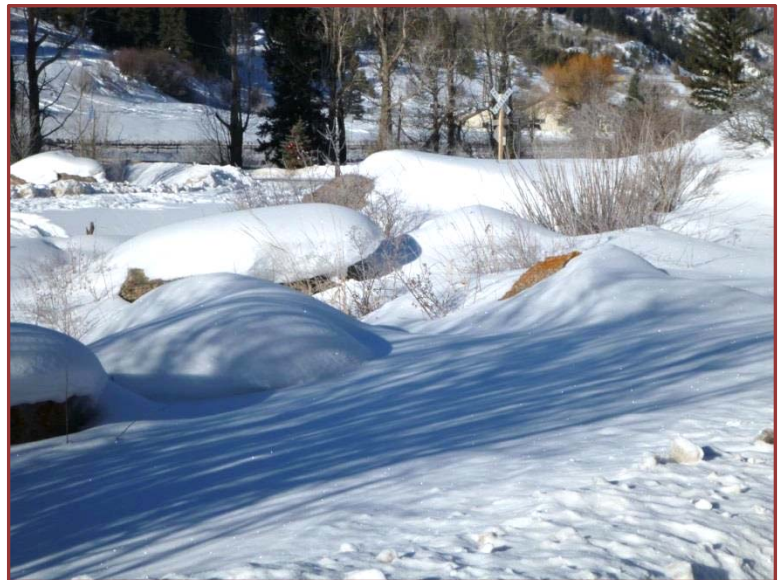
Farther north, however, scattered boulders were observed, more commonly above and just below the upper, alternative alignment, but also on the river terrace close to the preferred, lower alignment. The number of large boulders observed and the frequency of boulders near the

lower trail alignment generally increased farther north, and were most common in the northern $\frac{1}{3} \pm$ of the trail. We consider the risk of rockfall to be moderate for the central portion of the trail and relatively high for the northern portion. The rock fall risk for the upper, alternative trail is somewhat higher than for the lower preferred alignment. This must be understood as relative to other areas where there is little or no risk of rock falls at all, however. The risk will be elevated during periods of heavy rainfall and snow melt, but in drier periods, the likelihood of a dangerous rock fall on a given day, for example, is low, even for the northern end of the alignment.

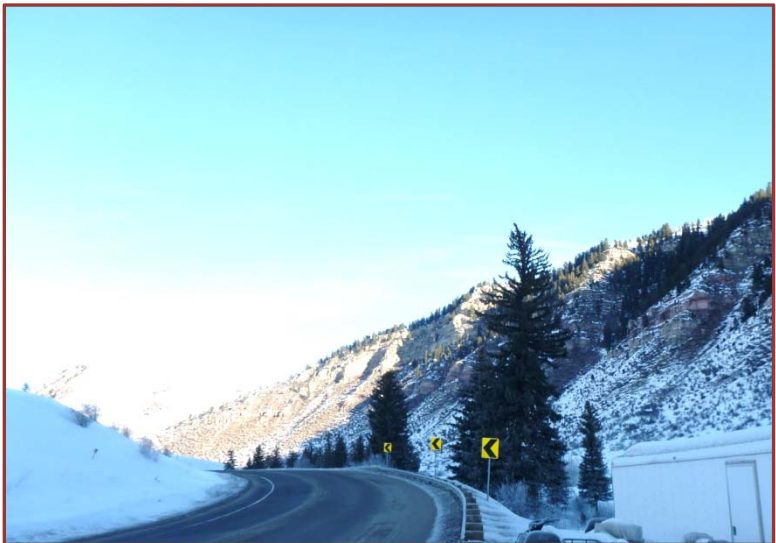
Avalanche Chutes In addition, a number of possible avalanche chutes were noted in the steep slopes overlooking the trail alignments. Examples can be seen in the photograph at right. These may represent an elevated risk of avalanches to at least portions of the trails, presumably to the upper, alternative alignment in particular. If avalanches are a design consideration, a specialist should be consulted in that regard.
