RE: Wetland Delineation Report – ECO Trails Project, Minturn Segment

# Wetland Delineation

## ECO Trails Project – Minturn Segment

Eagle County, Colorado

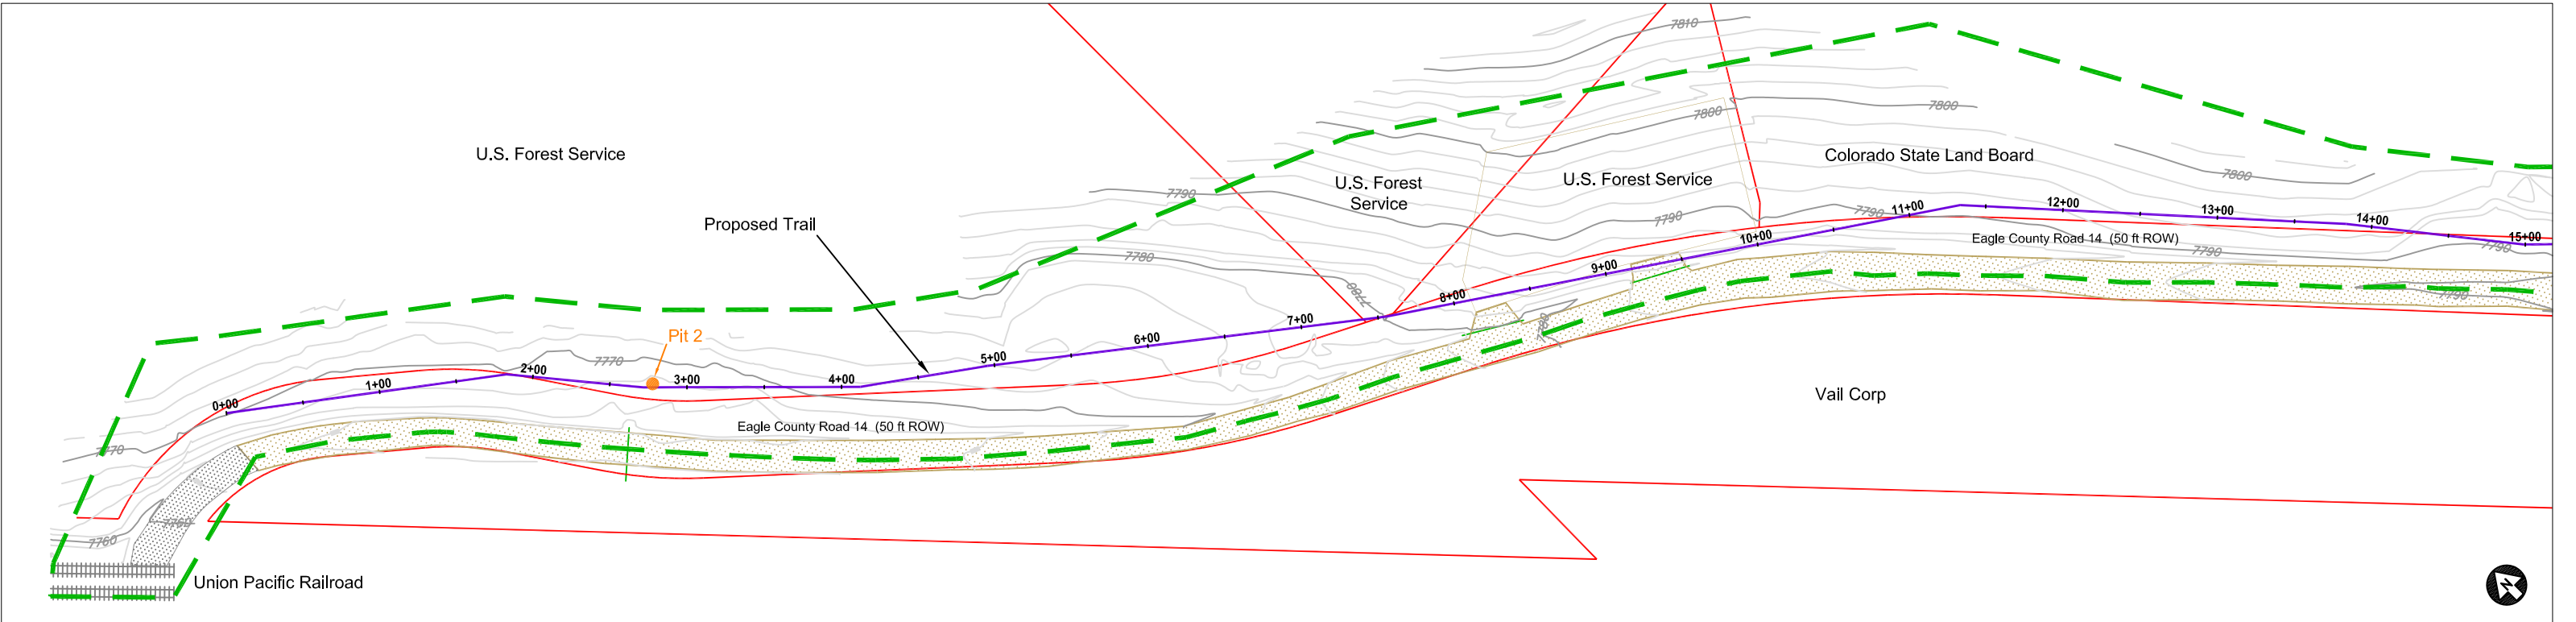
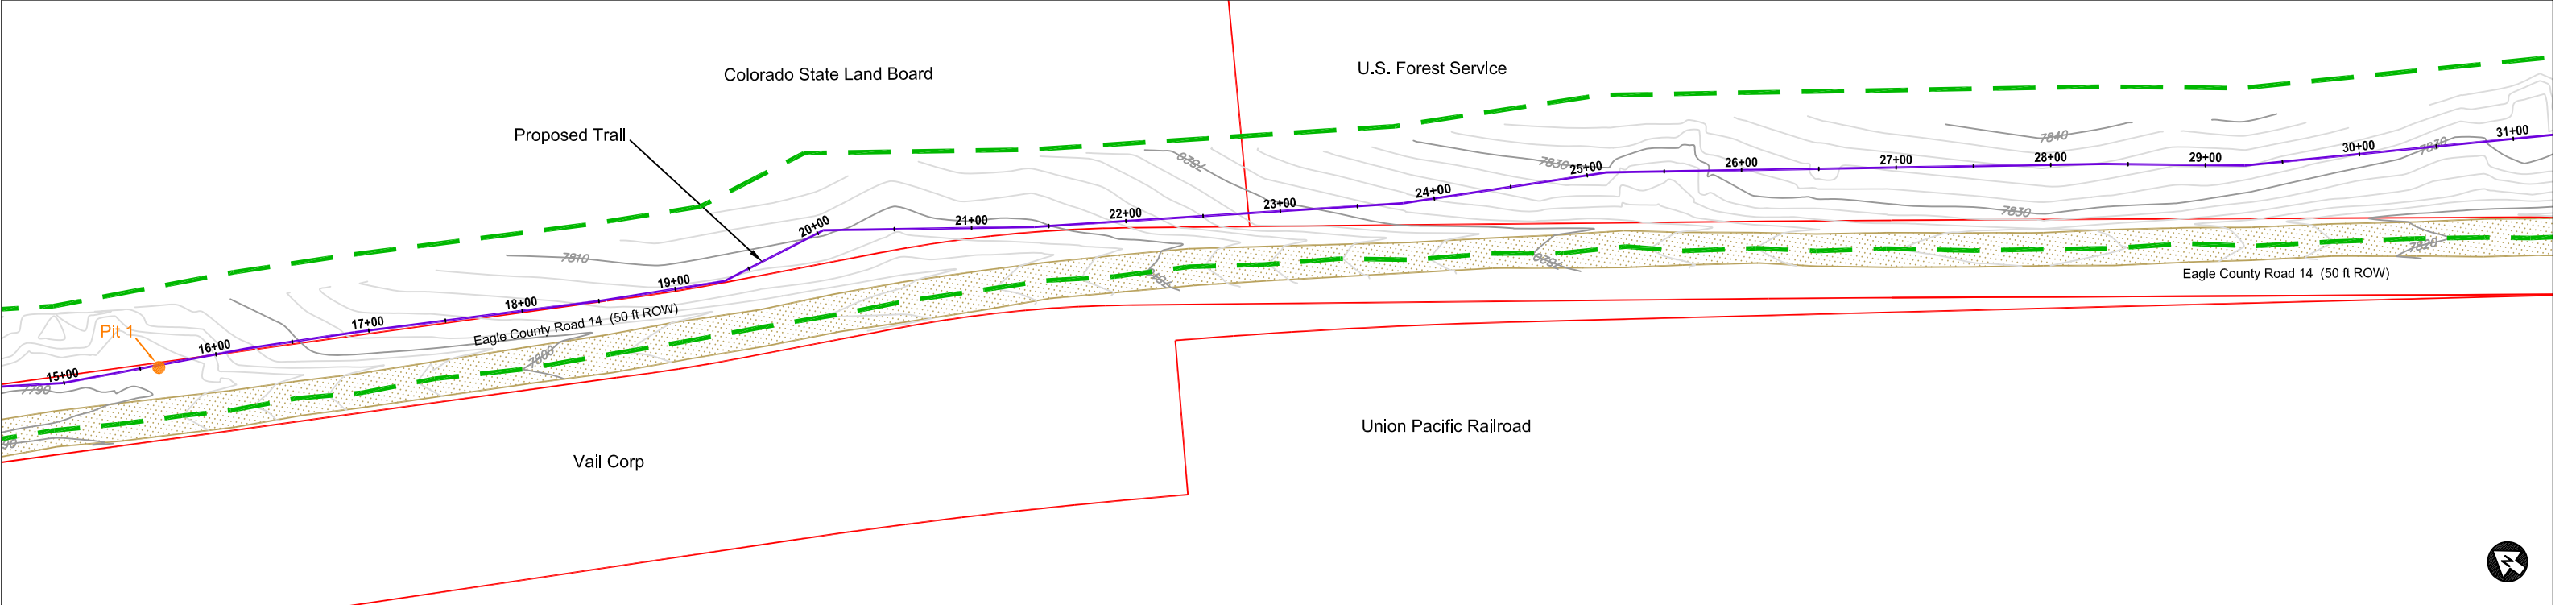
**Figure 2. Wetland Map Sheet 1 of 2  
 Minturn Trail Segment  
 ECO Trails Project**

The Wetland Map (Figure 2, Sheets 1 and 2) illustrates the boundary of the wetland delineation and the four soil pits evaluated along the proposed trail alignment. Wetlands were identified along Game Creek, a perennial stream that crosses the proposed trail near station 45+00. Approximately 908 square feet of riparian forested wetlands and 1,002 square feet of aquatic habitat were delineated along Game Creek within the trail project area, as illustrated by Figure 3.

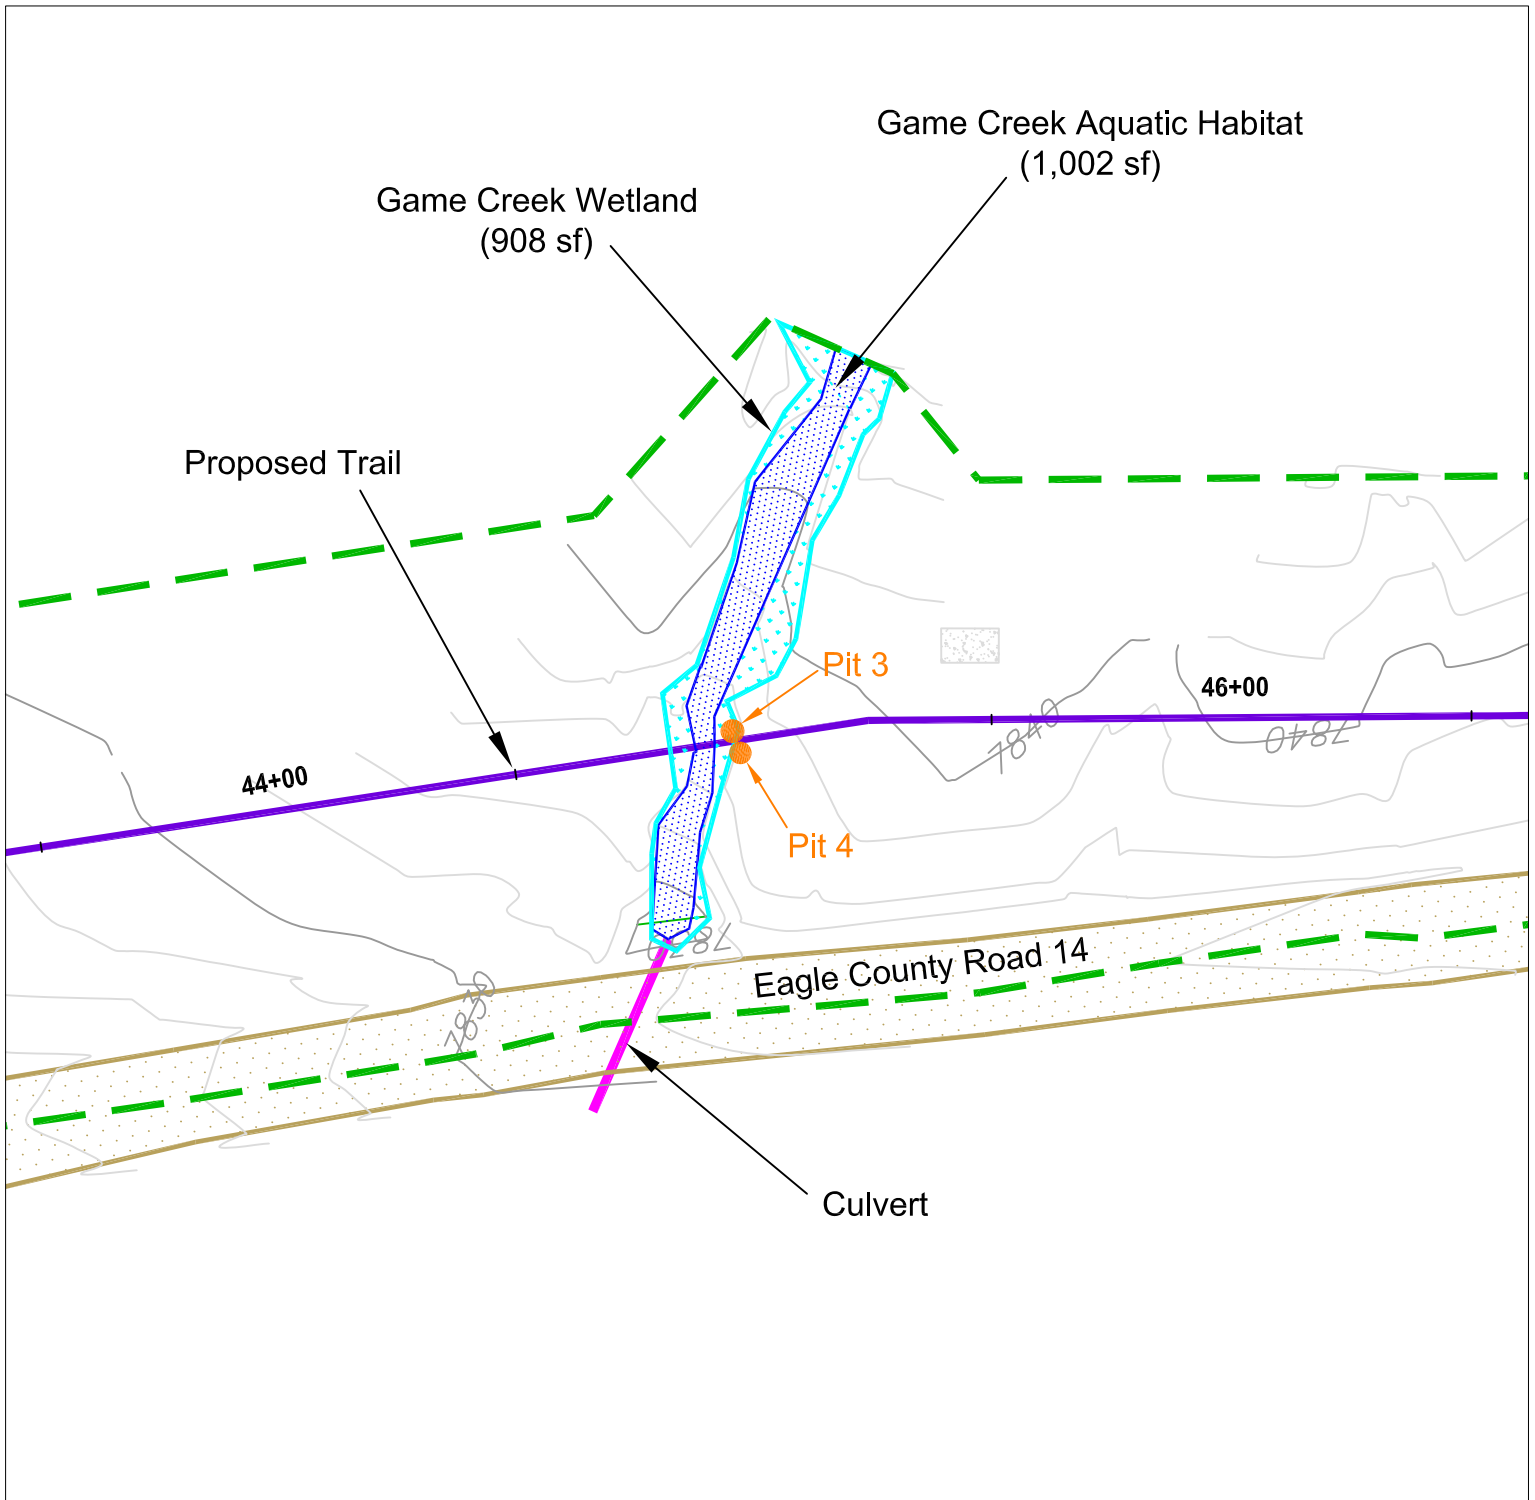
**Figure 3. Game Creek Wetland Detail  
 Minturn Trail Segment  
 ECO Trails Project**

Four soil pits were evaluated during the wetland delineation. Pits 1 and 2 are located in upland areas within the northern portion of the Minturn Trail project site. Pit 1 is in a poorly developed drainage swale that has hydrophytic vegetation, but lacks hydric soil and indicators of a wetland hydrology. Pit 2 is in another poorly developed swale through a stand of aspen (Photo 4). Pit 2 also lacked hydric soil and indicators of a wetland hydrology.

Pits 3 and 4 are paired pits located along Game Creek (Photo 9). Pit 3 is located on a small floodplain area on the south side of the channel. The hydric soil in Pit 3 had a redox dark surface, and was saturated below a depth of 11 inches on the date of the delineation. Pit 4 is located in the upland position adjacent to Game Creek. Pit 4 is approximately six inches higher in elevation than Pit 3. Pit 4 lacked hydric soil and indicators of a wetland hydrology.

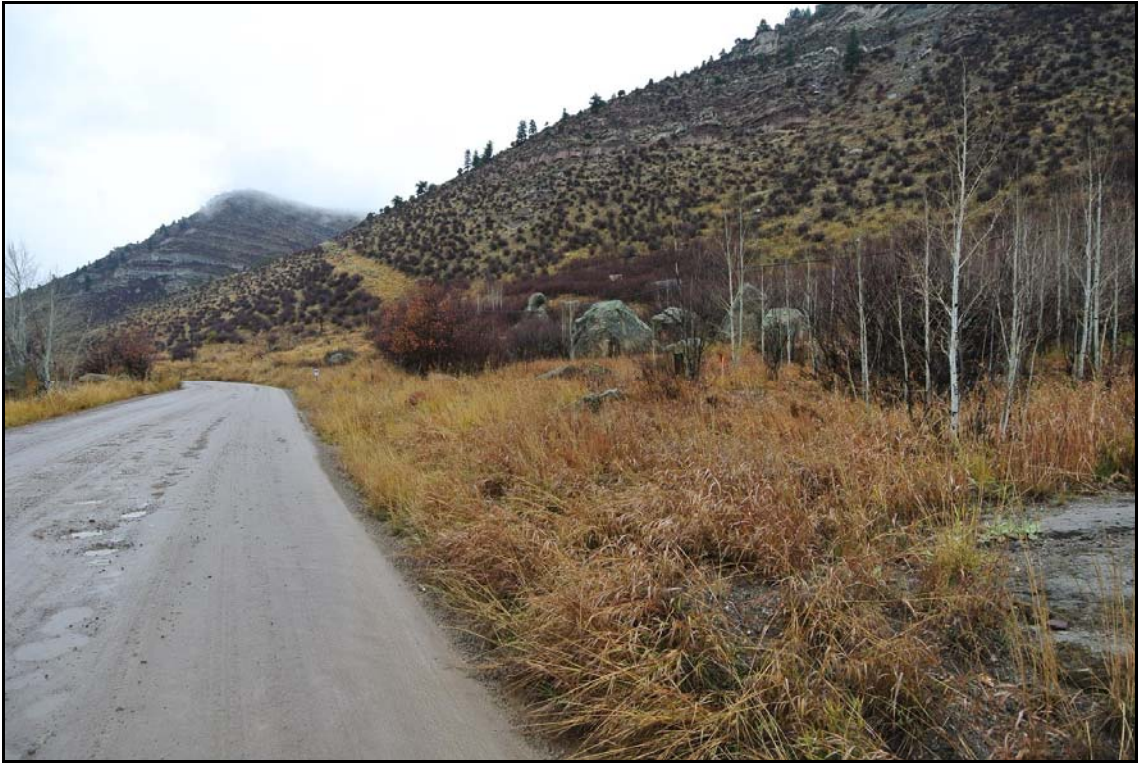
**Photo 1.** Overview of the trail project area, view to the north along the east side of County Road 14. (10/26/15).

The proposed Minturn Segment of the ECO Trail system would be located east of County Road 14, and would approximately parallel the road (Photos 1 & 2). Portions of the trail would be located within the County Road 14 ROW, however as illustrated by Figure 2, it would also cross onto properties owned by the U.S. Forest Service, the Colorado State Land Board, and the Union Pacific Railroad. As described above, the northern end of the trail would begin in a disturbed area just east of the Union Pacific Railroad and the County Road 14 Bridge over the Eagle River (Photo 3). The majority of the proposed trail would be constructed through mountain shrublands and small stands of aspen in a lightly disturbed area just east of the unpaved County Road (Photos 4-6). However, in some areas the plant community has been degraded by invasive noxious weeds such as toadflax (*Linaria vulgaris*) (Photo 7).

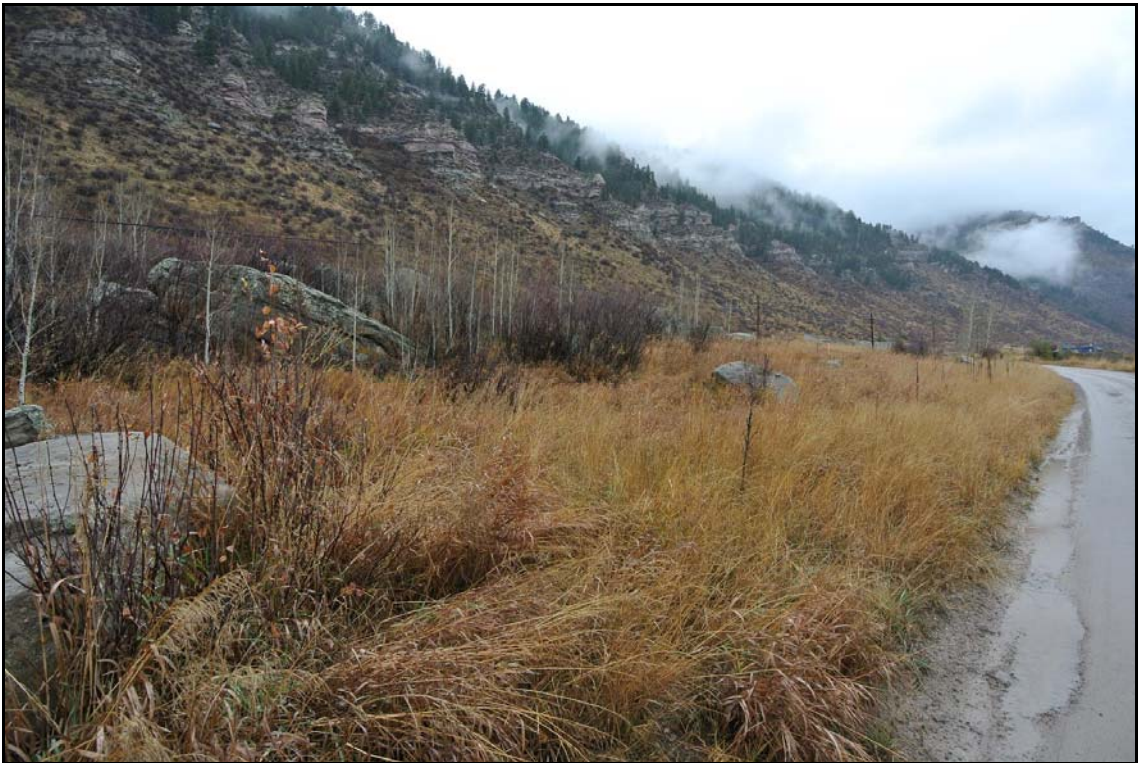
**Photo 2.** Overview of the trail project area, view to the south along the east side of County Road 14. (10/26/15).

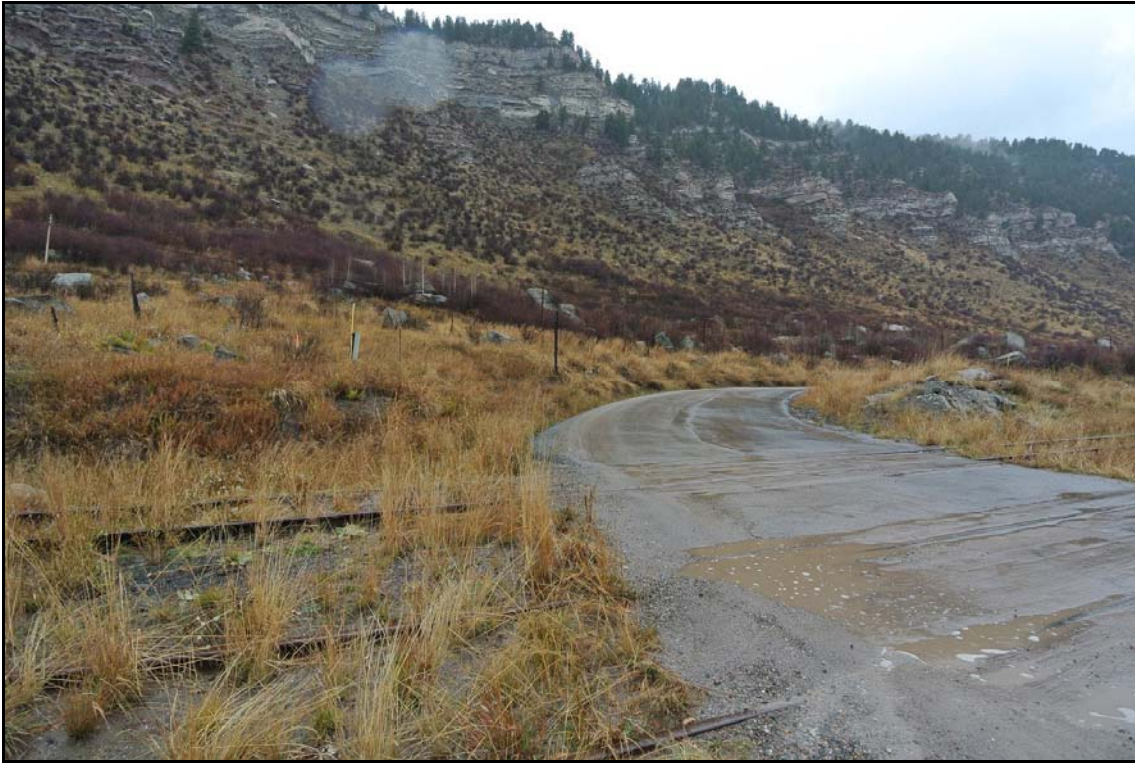
**Photo 3.** The northern end of the Minturn trail segment will begin in a disturbed area just east of the railroad and the County Road 14 Bridge over the Eagle River. (10/26/15).

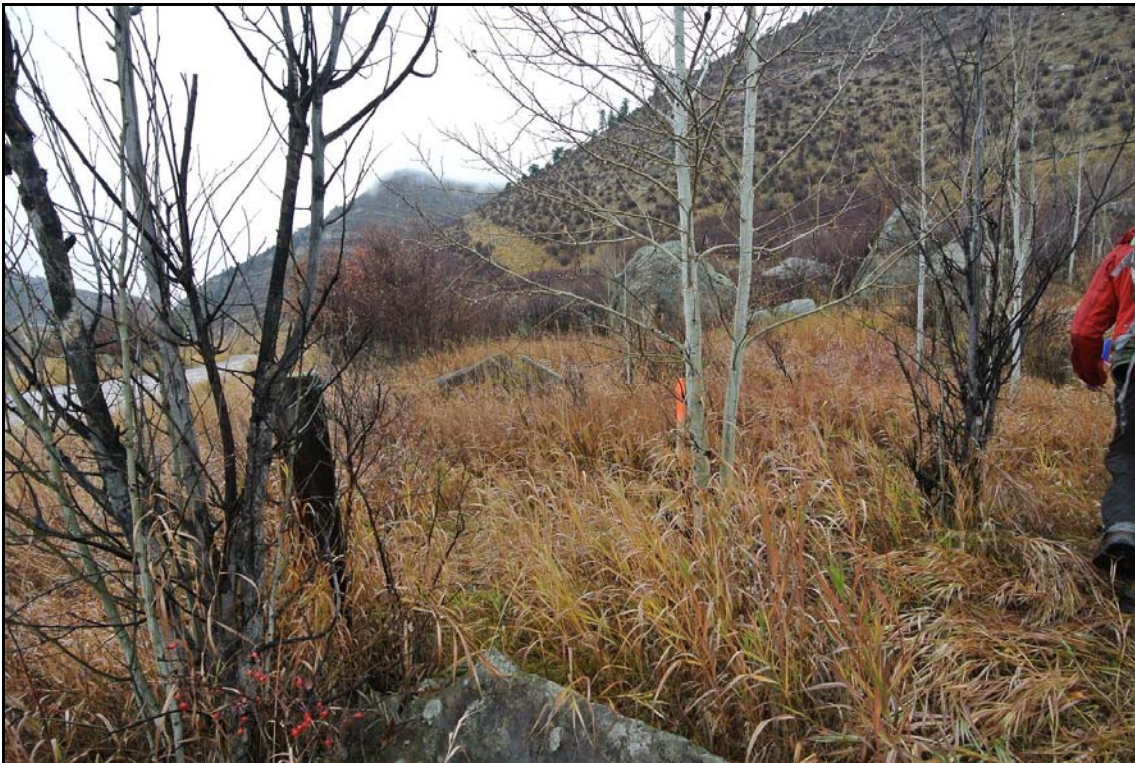
**Photo 4.** Proposed trail corridor adjacent to Pit 2, which did not meet the vegetation, soil, or hydrology criteria of the Corps manual. (10/26/15).

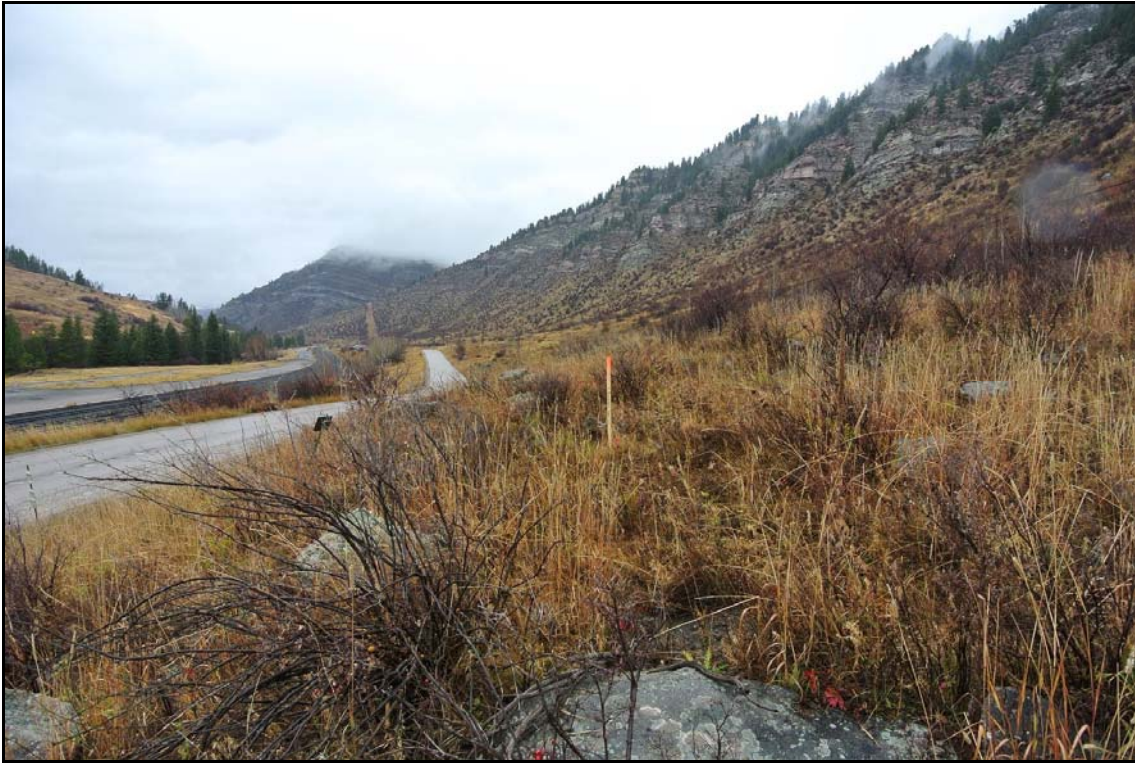
**Photo 5.** The orange stake marks the proposed trail centerline through the mountain shrub community east of County Road 14. (10/26/15).

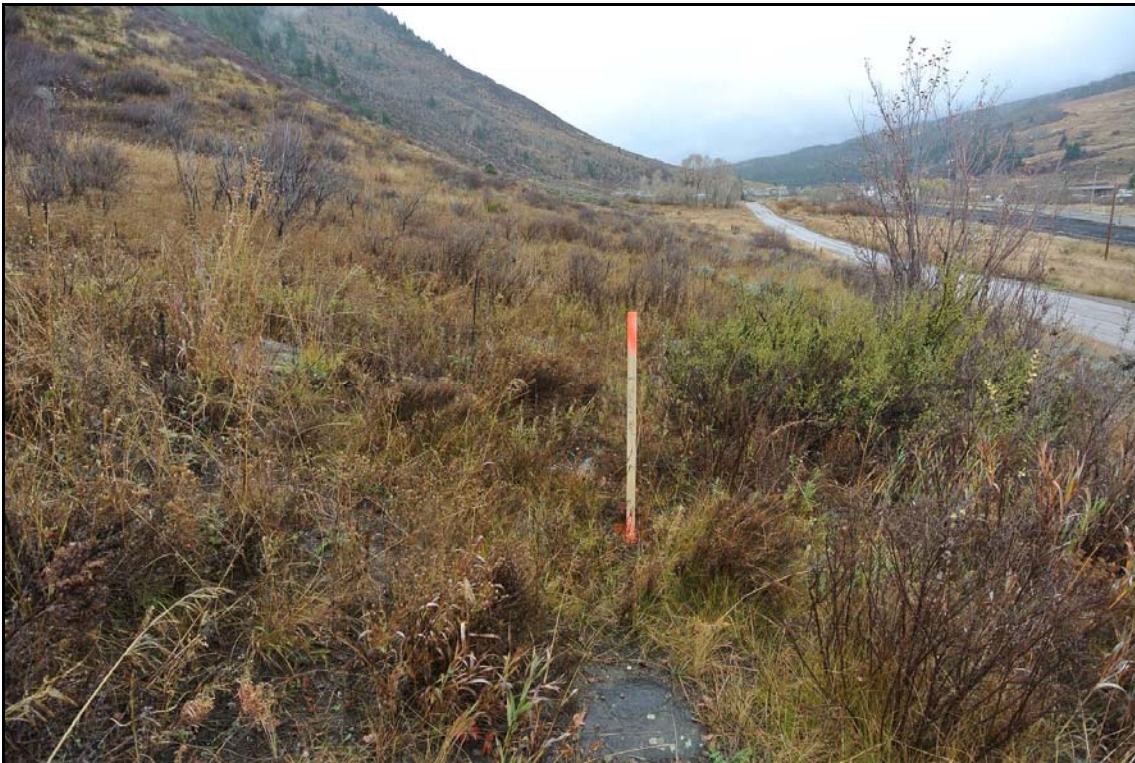
**Photo 6.** Proposed trail alignment through the upland mountain shrub community. (10/26/15).

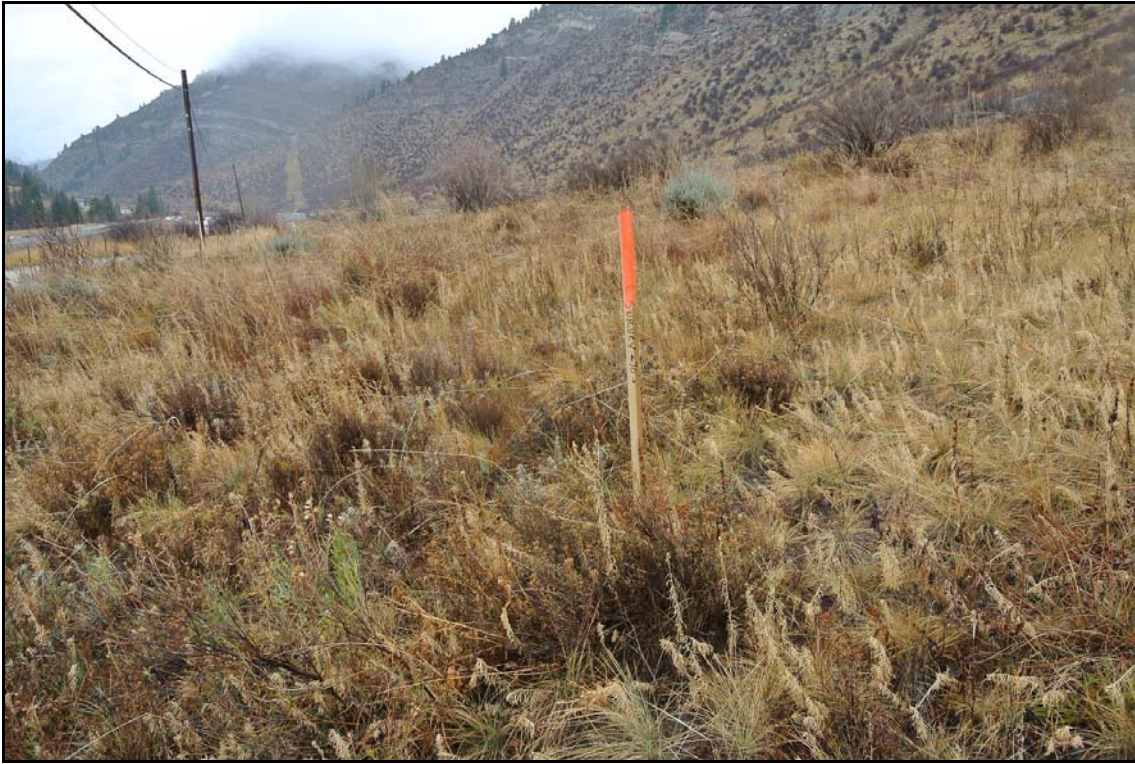
**Photo 7.** This section of the proposed trail would cross an area with a high cover of the noxious weed toadflax. (10/26/15).

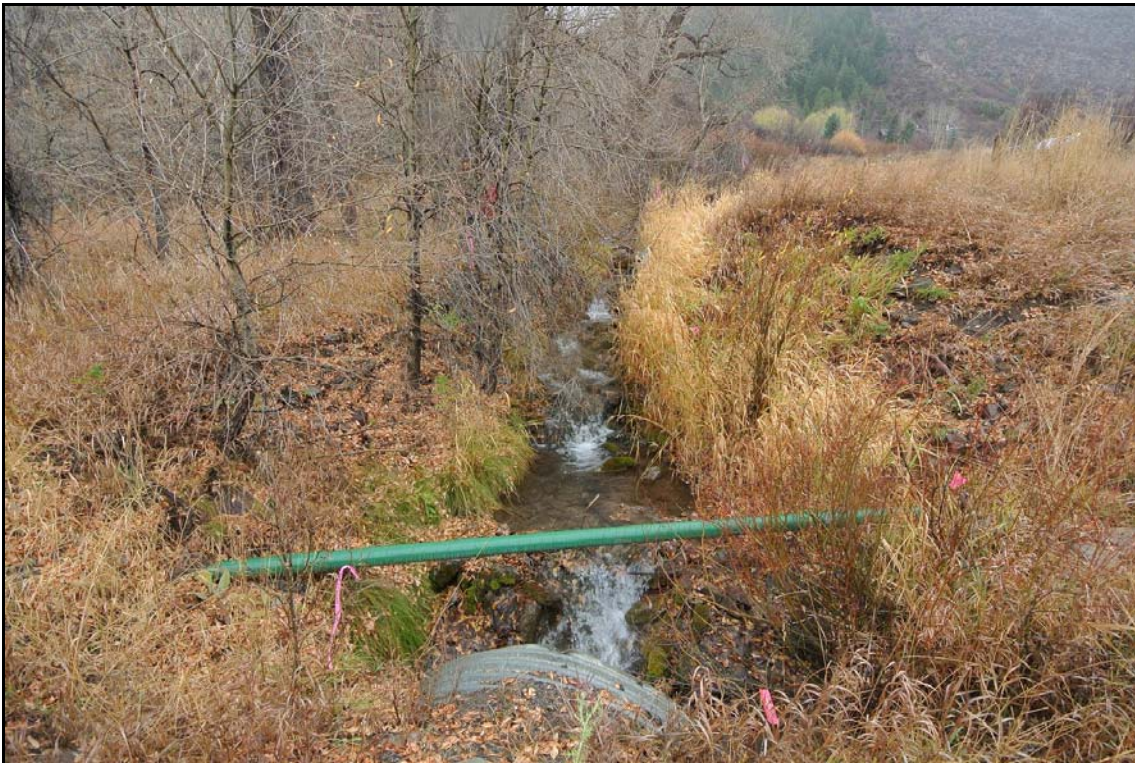
**Photo 8.** Game Creek is a perennial tributary of the Eagle River. (10/26/15).

Game Creek, a perennial tributary of the Eagle River, crosses the proposed trail corridor approximately 850 feet north of the junction of 6th Avenue and Minturn Road (Photo 8). The creek flows into a culvert below County Road 14, continues west below the railroad, and joins the Eagle River approximately 430 feet to the west of County Road 14. Elevations of the wetland delineation area range from a high of approximately 7,848 feet at the upstream end of Game Creek to a low of 7,770 feet in the north.

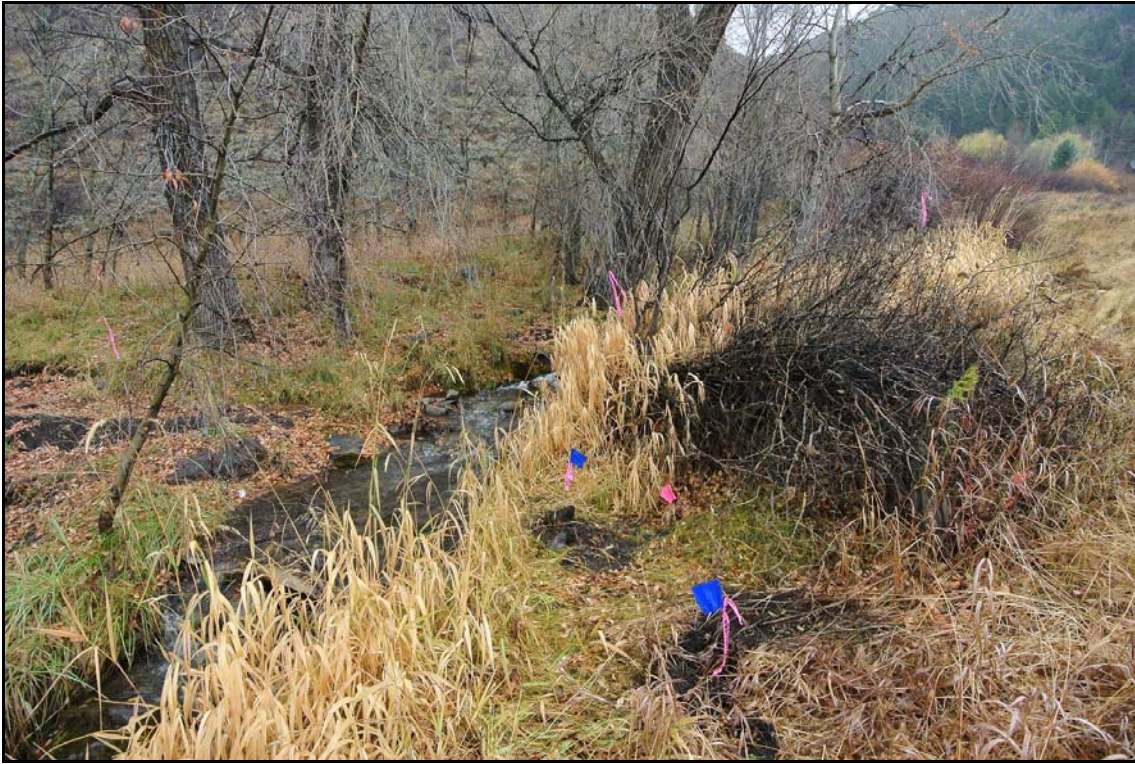
**Photo 9.** Paired soil pits 3 and 4 at the margin of the Game Creek Wetland. (10/26/15).

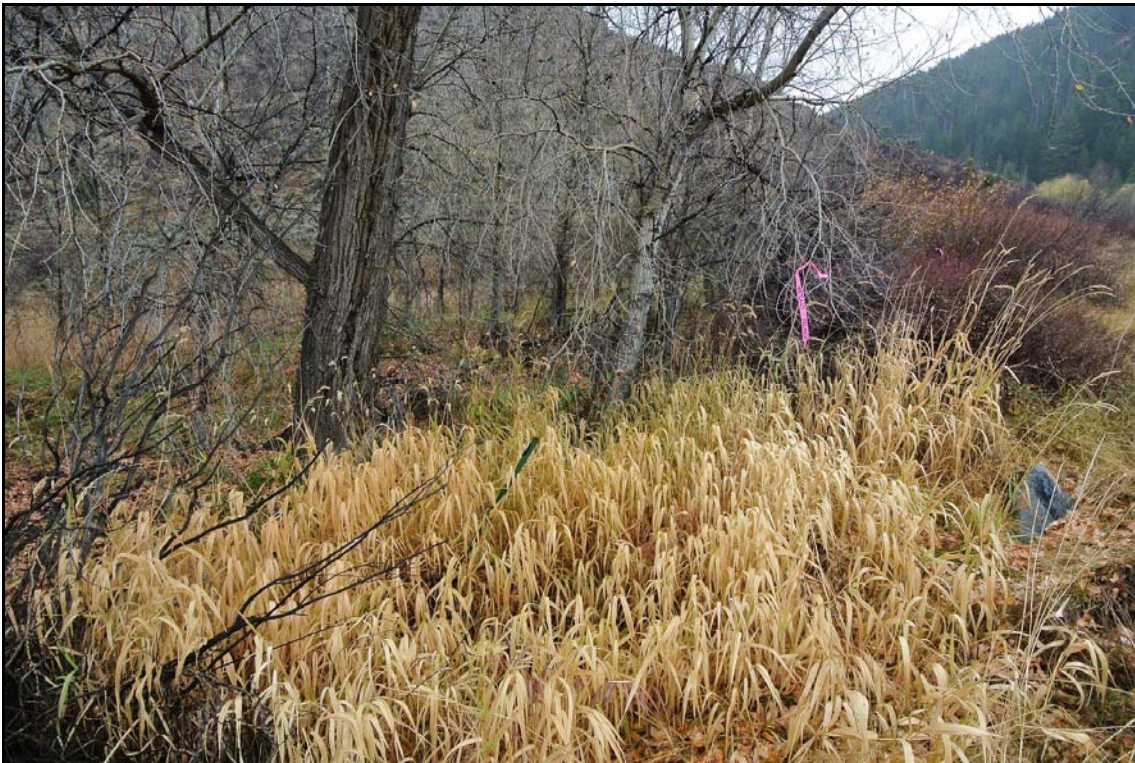
**Photo 10.** Reed canarygrass is the most abundant herbaceous species in the wetland understory. This is an aggressive, introduced grass. (10/26/15).

Within the Minturn Trail project area, the Game Creek Wetland has a riparian overstory that is dominated by narrowleaf cottonwood (*Populus angustifolia*) and balsam poplar (*Populus balsamifera*) trees, with a few aspen (*Populus tremuloides*) (Photos 8 & 9). The diverse shrub layer includes mountain and Drummond willows (*Salix monticola*; *S. drummondiana*), redosier dogwood (*Cornus serotina*), thinleaf alder (*Alnus incana* ssp. *tenuifolia*), snowberry (*Symphoricarpos rotundifolius*), and serviceberry (*Amelanchier alnifolia*). The herbaceous wetland understory is dominated by reed canarygrass (*Phalaris arundinacea*), an aggressive introduced species (Photo 10). Orchard grass (*Dactylis glomerata*), a facultative upland grass, is common in the shady areas of the understory. Table 2 lists the vascular plant species observed in the Minturn Trail project area during the wetland delineation.
