Geotechnical Evaluation West Lake Creek Road Bridge Over East Lake Creek Edwards, Colorado

Job Number: 23-6012

December 7, 2023

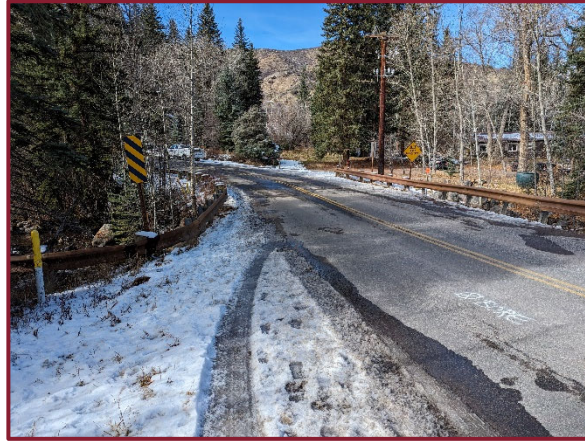
At the time of our subsurface exploration, the project site was developed as a single-span, two-lane bridge carrying West Lake Creek Road over East Lake Creek. Relatively minor to moderate signs of distress were observed on the asphalt-paved bridge deck, including longitudinal and transverse cracking, small depressions, and local patch failures.

Steel decking was visible on the edges of the bridge. The area beneath the bridge was generally inaccessible, but we observed that the bridge had concrete wing walls and abutments. The bridge deck appeared to be supported by steel I-beams.

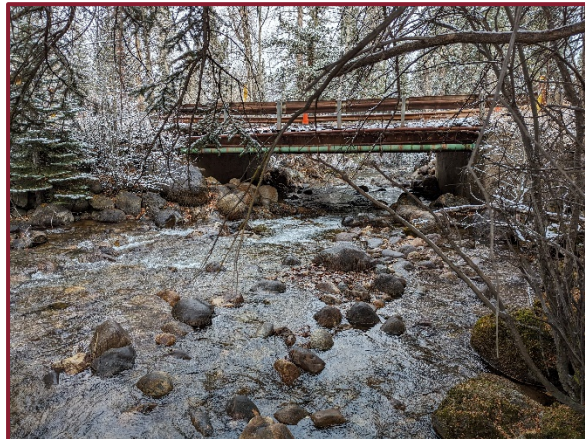
The creek flowed northward with several feet of water in the channel. Stream stage was approximately 10 feet below the bridge deck at the time of our field work. The channel contained numerous boulders, up to about 4 feet in diameter.

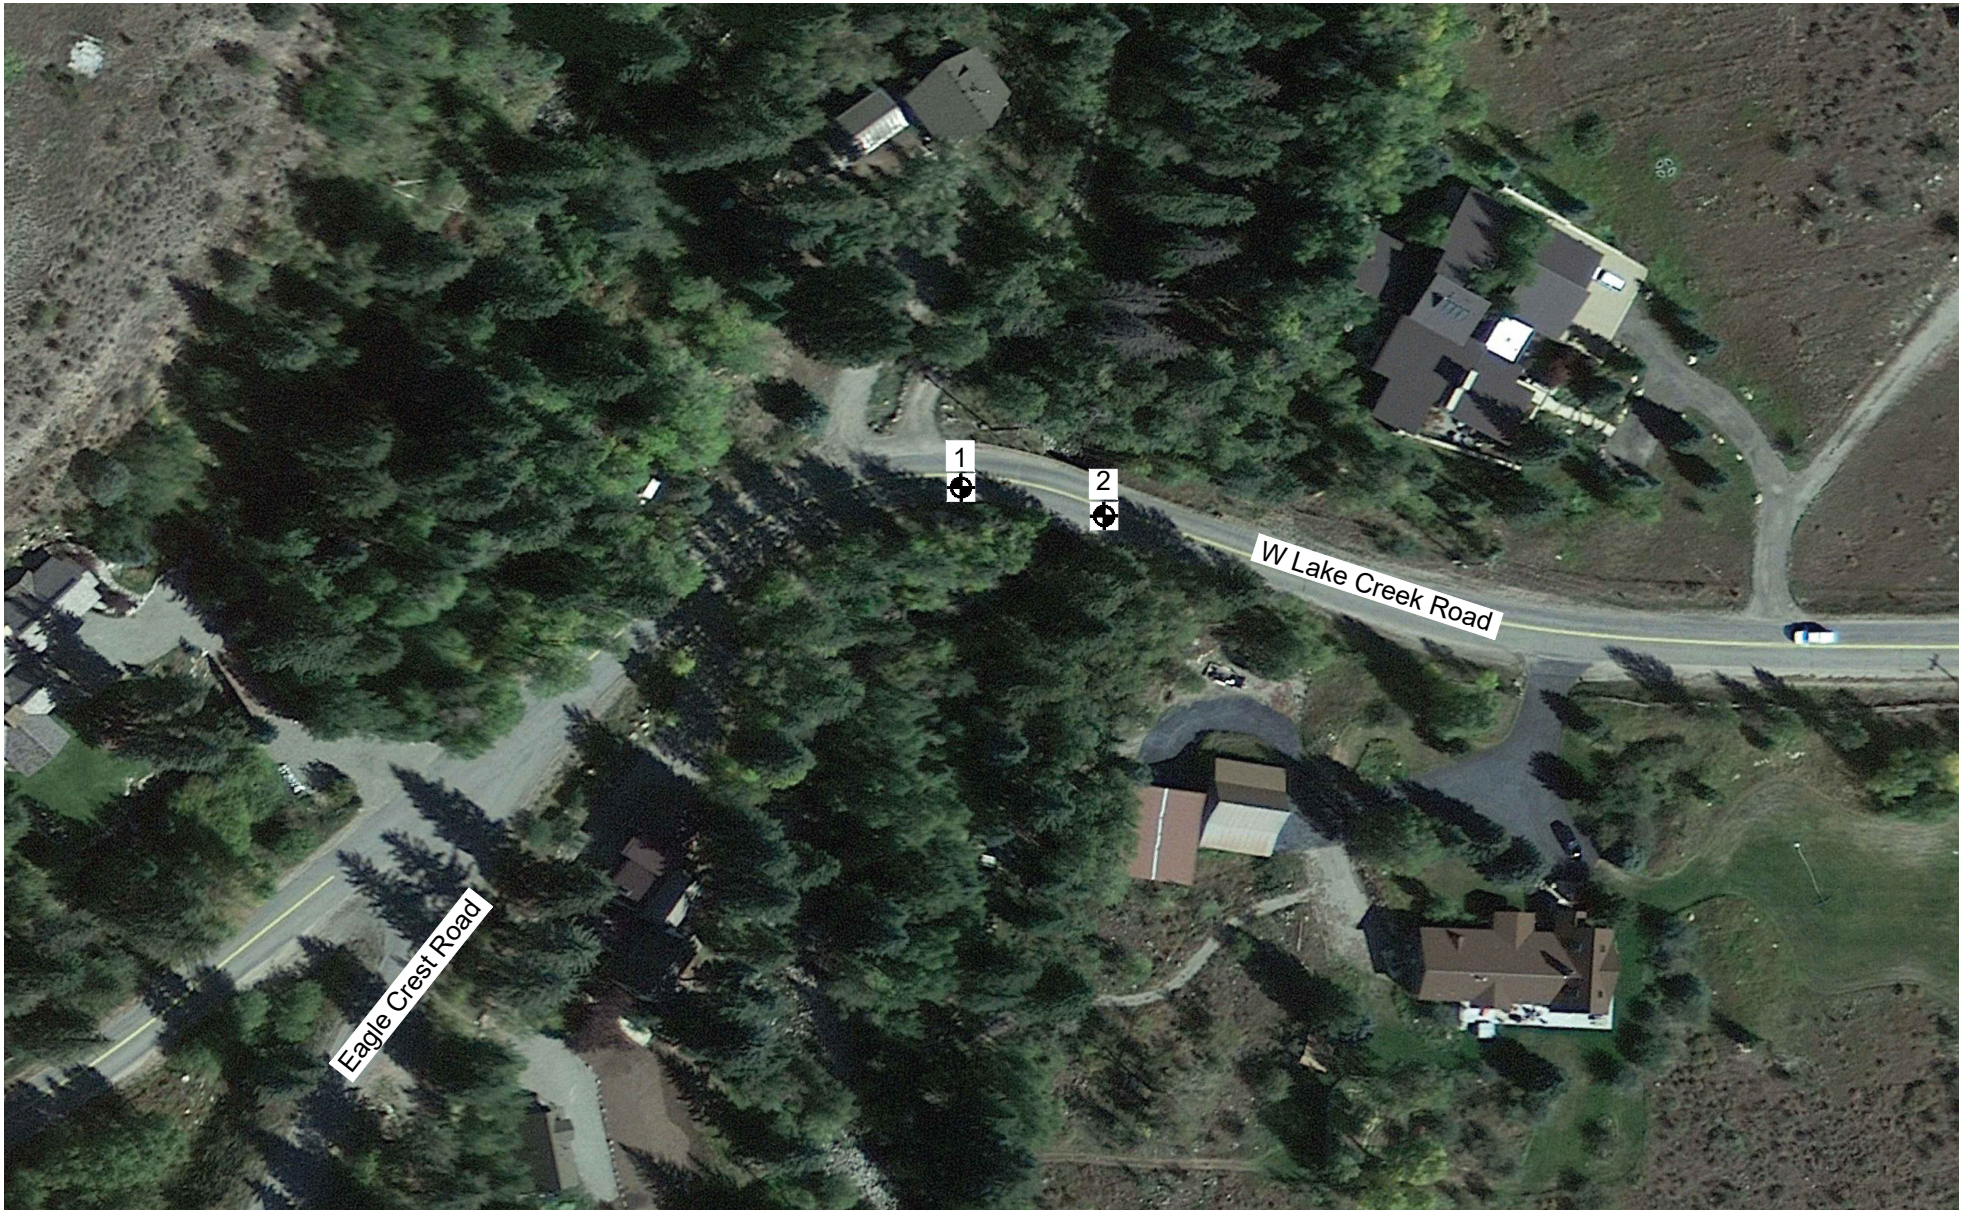
GOOGLE EARTH AERIAL IMAGE (09/13/2019)

2
⊕ Indicates test hole numbers and approximate locations.

The geotechnical conclusions in this report relied upon subsurface exploration at a single exploration point, as shown in Figure 1, as well as the means and methods described herein. Subsurface conditions were interpolated between and extrapolated beyond these locations. It is not possible to guarantee the subsurface conditions are as indicated in this report. Actual conditions exposed during construction may differ from those encountered during site exploration.

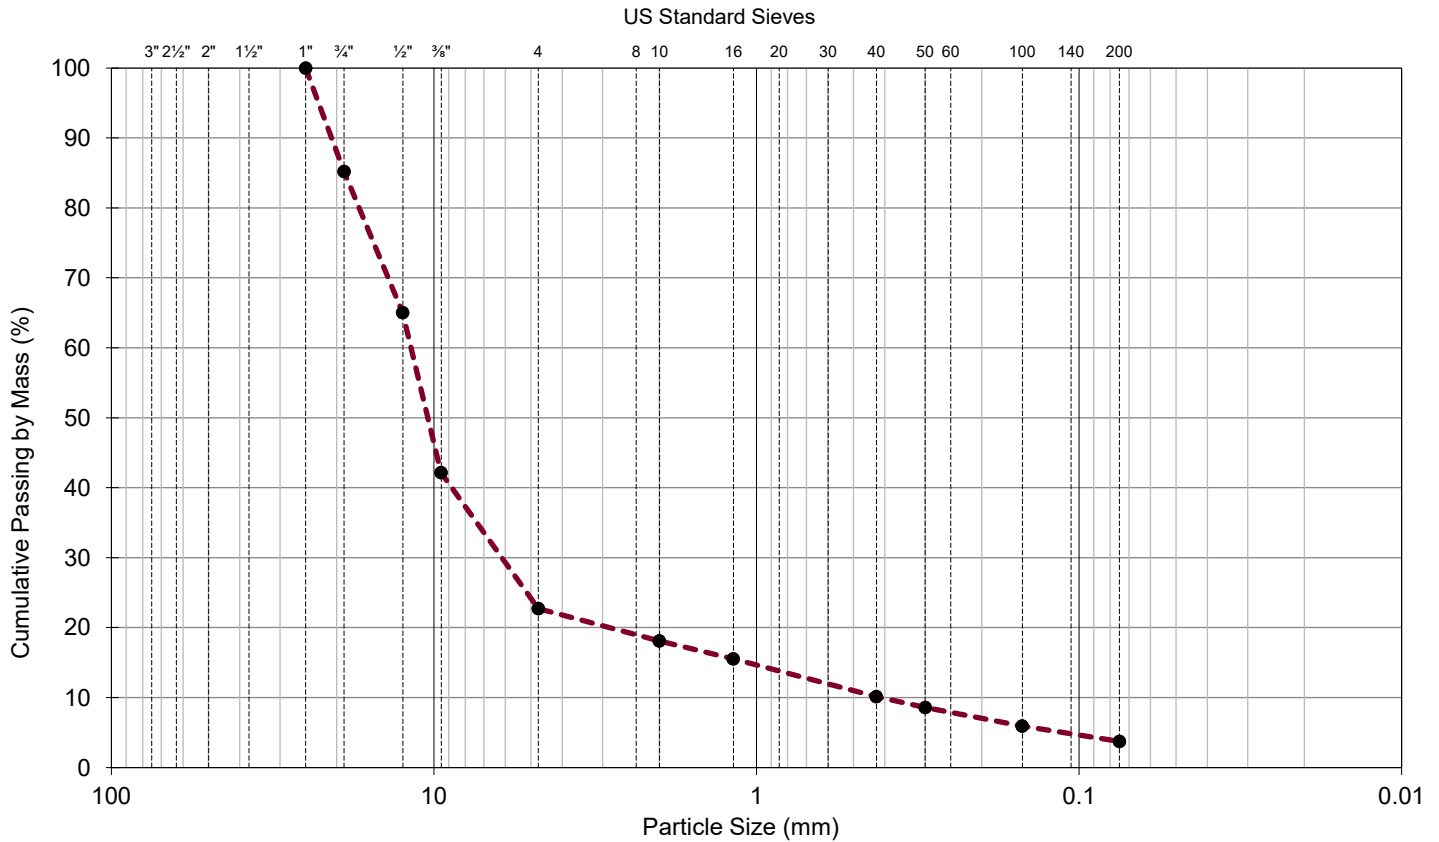
Gradation (ASTM D422-63[2007])

Coarse Gradation			Fine Gradation			Grading	
US Standard Sieve	Particle Size (mm)	Passing by Mass (%)	US Standard Sieve	Particle Size (mm)	Passing by Mass (%)	Coefficient	Value
6 in	150	-	No. 4	4.75	23	D90	20.768
5 in	125	-	No. 8	2.36	-	D85	18.921
4 in	100	-	No. 10	2.00	18	D80	17.055
3 in	75	-	No. 16	1.18	16	D60	11.767
2.5 in	63	-	No. 20	0.85	-	D50	10.438
2 in	50	-	No. 30	0.60	-	D40	8.800
1.5 in	37.5	-	No. 40	0.425	10	D30	6.162
1 in	25.0	100	No. 50	0.300	9	D15	1.069
3/4 in	19.0	85	No. 60	0.250	-	D10	0.411
1/2 in	12.5	65	No. 100	0.150	6	D05	0.112
3/8 in	9.5	42	No. 140	0.106	-	Cu	28.639
No. 4	4.75	23	No. 200	0.075	3.7	Cc	7.852

Location: 1 at 8 feet
Description: GRAVEL with Sand

Samples retrieved from our test holes were examined and visually classified in the laboratory by the project engineer. Laboratory testing of soil samples included standard property tests, such as natural moisture contents, dry unit weights, grain size analyses, and Atterberg limits. Water-soluble sulfate content and a suite of corrosivity tests were completed on selected samples, as well. Laboratory tests were performed in general accordance with applicable ASTM protocols. Results of the laboratory testing program are summarized in Tables 1 and 2. Gradation plots are provided in Figures 4, 5, and 6.

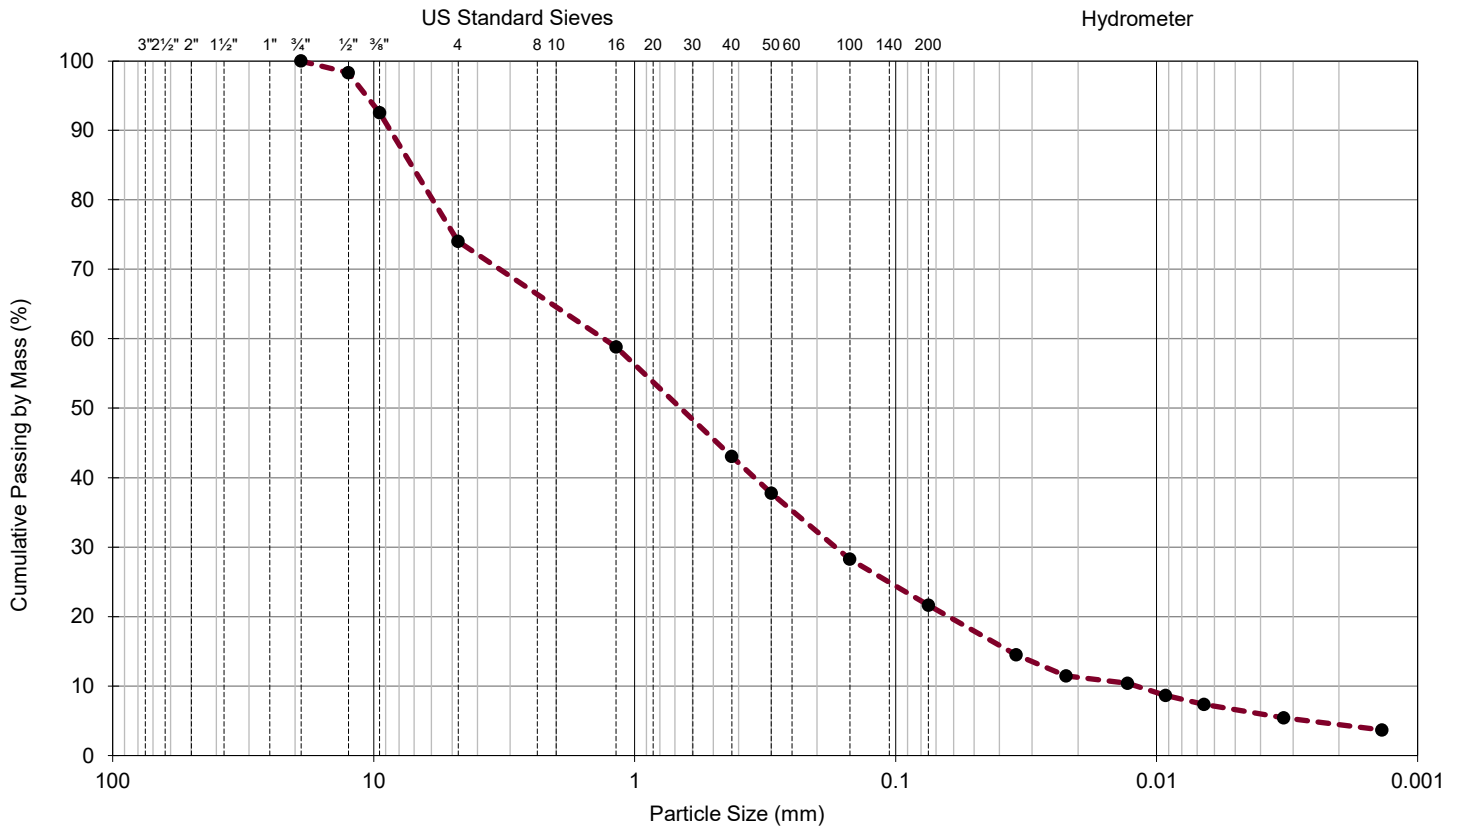
Gradation and Hydrometer (ASTM D422-63[2007])

Coarse Gradation			Fine Gradation			Hydrometer		Grading	
US Standard Sieve	Particle Size (mm)	Passing by Mass (%)	US Standard Sieve	Particle Size (mm)	Passing by Mass (%)	Particle Size (mm)	Passing by Mass (%)	Coefficient	Value
6 in	150	-	No. 4	4.75	74	0.035	15	D90	8.638
5 in	125	-	No. 8	2.36	-	0.022	11	D85	7.162
4 in	100	-	No. 10	2.00	-	0.013	10	D80	5.938
3 in	75	-	No. 16	1.18	59	0.009	9	D60	1.317
2.5 in	63	-	No. 20	0.85	-	0.007	7	D50	0.666
2 in	50	-	No. 30	0.60	-	0.003	5	D40	0.347
1.5 in	37.5	-	No. 40	0.425	43	0.001	4	D30	0.170
1 in	25.0	-	No. 50	0.300	38	-	-	D15	-
3/4 in	19.0	100	No. 60	0.250	-	-	-	D10	-
1/2 in	12.5	98	No. 100	0.150	28	-	-	D05	-
3/8 in	9.5	93	No. 140	0.106	-	-	-	Cu	-
No. 4	4.75	74	No. 200	0.075	21.6	-	-	Cc	-

Location: Composite - Test Holes
 Description: Silty SAND with Gravel

4) Footings should be provided with adequate soil cover above their bearing elevation for frost protection. Therefore, footings should be placed at a bearing elevation of at least 4 feet below the lowest adjacent finish grades. Additional embedment may be required for scour protection. Hydrometers plots are provided in Figures 5 and 6 may be used for scour design.

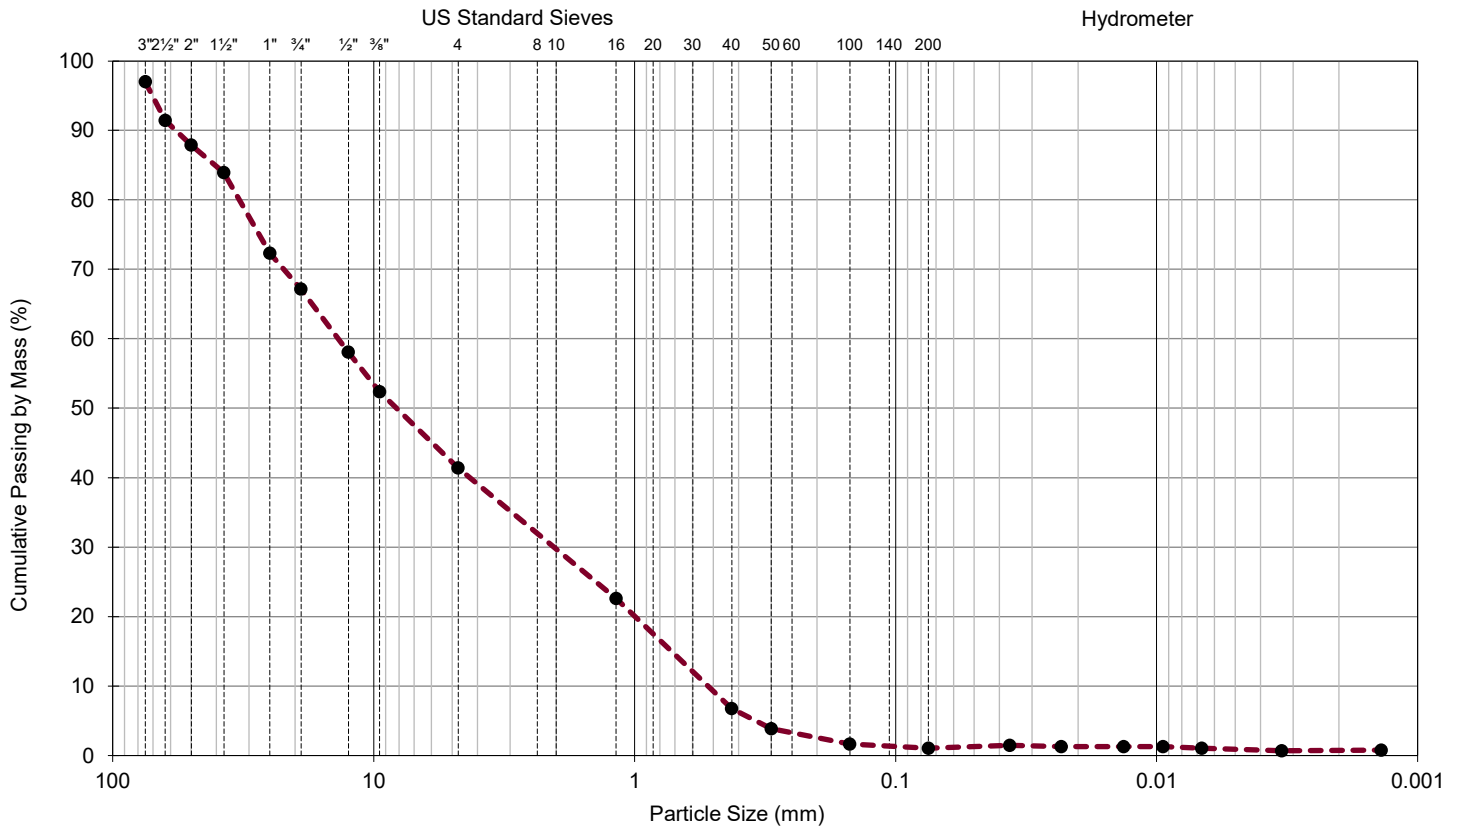
Gradation and Hydrometer (ASTM D422-63[2007])

Coarse Gradation			Fine Gradation			Hydrometer		Grading	
US Standard Sieve	Particle Size (mm)	Passing by Mass (%)	US Standard Sieve	Particle Size (mm)	Passing by Mass (%)	Particle Size (mm)	Passing by Mass (%)	Coefficient	Value
6 in	150	-	No. 4	4.75	41	0.037	1	D90	57.367
5 in	125	-	No. 8	2.36	-	0.023	1	D85	40.540
4 in	100	-	No. 10	2.00	-	0.013	1	D80	32.698
3 in	75	97	No. 16	1.18	23	0.009	1	D60	13.645
2.5 in	63	91	No. 20	0.85	-	0.007	1	D50	8.177
2 in	50	88	No. 30	0.60	-	0.003	1	D40	4.278
1.5 in	37.5	84	No. 40	0.425	7	0.001	1	D30	2.040
1 in	25.0	72	No. 50	0.300	4	-	-	D15	0.722
3/4 in	19.0	67	No. 60	0.250	-	-	-	D10	0.523
1/2 in	12.5	58	No. 100	0.150	2	-	-	D05	0.344
3/8 in	9.5	52	No. 140	0.106	-	-	-	Cu	26.087
No. 4	4.75	41	No. 200	0.075	1.0	-	-	Cc	0.583

Location: Composite - Channel
Description: GRAVEL with Sand

Gravel (%): 59
Sand (%): 40
Silt/Clay (%): 1
< .002 mm (%): 1
